CITY OF BLUFFTON

ADA Self Evaluation & Compliance Barriers

Prepared by: USI Consultants

July 2023

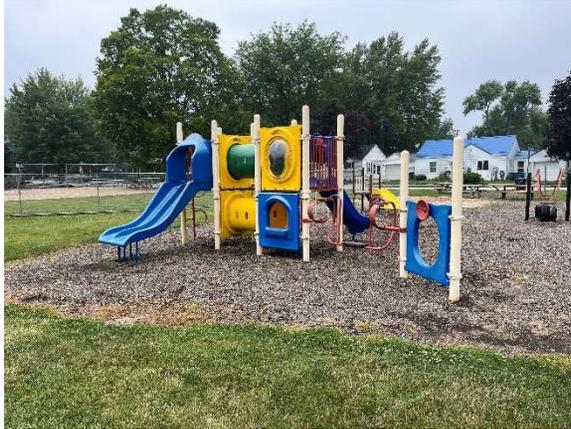
South Side of Play Area

19. There is not an accessible route within the play area to connect play components	Add accessible playgrounds surface within play area	\$28,000	1
20. There is not an accessible route to the baseball/softball field	Add sidewalk to create accessible route	\$6,500	1
21. There is not an accessible route to seating area at baseball/softball field	Add sidewalk to create accessible route	\$3,000	1
22. There is no wheelchair space for spectators or players	Add concrete for wheelchair space	\$500	1
TOTAL WITHOUT PLAYGROUND SURFACE		\$48,200	
PLAYGROUND SURFACE COST		\$28,000	
TOTAL		\$76,200

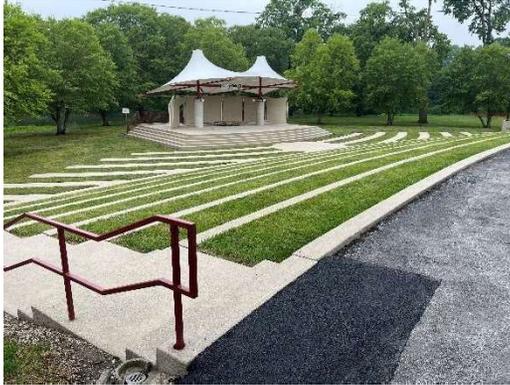
Stage and Seating Area

Kehoe Park	RECOMMENDATION	TOTAL COST	PRIORITY
1. There are no wheelchair spaces next to seats	Add concrete for wheelchair space	\$500	1
2. The ADA parking is not located closest to accessible route	Install accessible signage and markings to the area East of the businesses, near the bathrooms	\$2,500	1

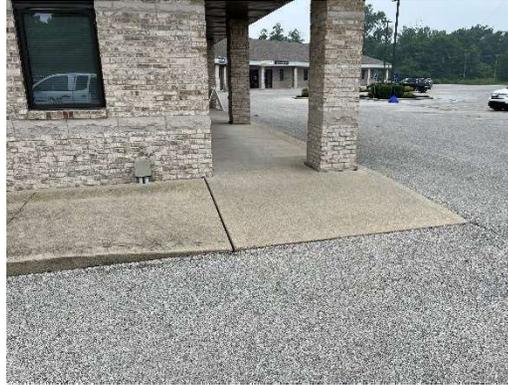
Accessible Route with ADA Parking in Background

3. The sidewalk transition along accessible route does not meet the cross-slope requirement of 1:48	Replace sidewalk transition	\$1,000	1
4. The van accessible handicap parking does not meet size specifications	Install accessible signage and markings to the area East of the businesses, near the bathrooms	See Item 2	1

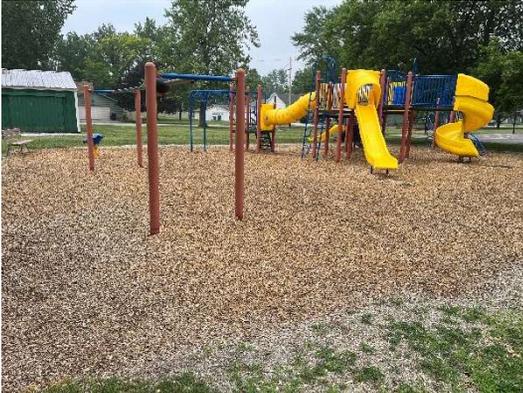
North Side of Main Play Area

14. The toilet paper dispenser does not meet the 48" maximum height	Relocate toilet paper dispenser	\$0	3
15. There is not an accessible route within the play area to connect play components	Add accessible playgrounds surface within play area	\$28,000 each	1

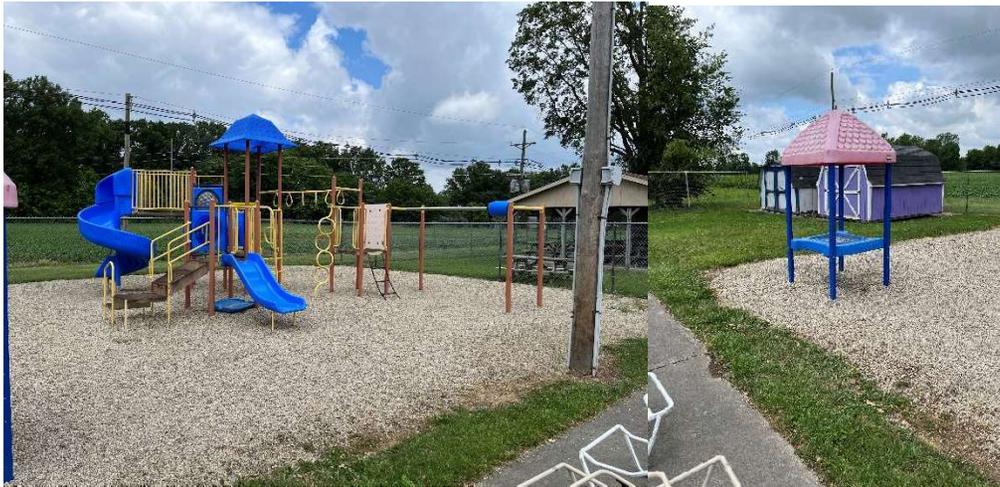
East side of play Area

21. There is not an accessible entrance to the entrance of the play area	Add sidewalk to create accessible route	\$3,000	1
22. There is not an accessible route within the play area to connect play components	Add accessible playgrounds surface within play area	\$28,000	1

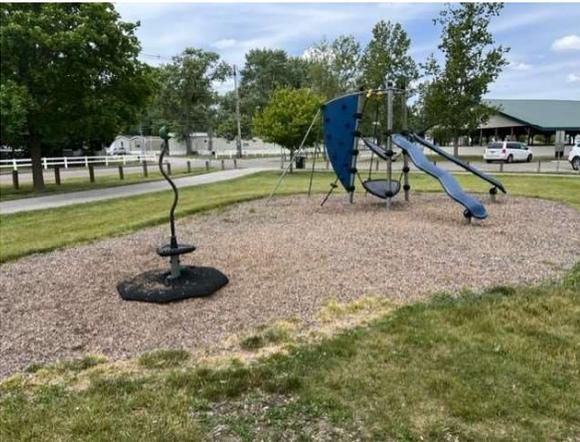
East Side of West Play Area

12. There are not pulls on both sides of the water closet door in the Men's and Women's room	Install door pulls	\$100	3
13. There is not an accessible route within the play area to connect play components	Add accessible playgrounds surface within play area	\$28,000	1
14. There is not an accessible route to the baseball field	Install a sidewalk to create accessible route	\$6,500	1
15. There is not an accessible route to player seating at the baseball field	Install a sidewalk to create accessible route	\$3,000	1
16. There is no wheelchair space for the team seating at the baseball field	Add concrete for wheelchair space	\$500 each	1
17. There is no route to connect both sides of the field/court for the baseball and basketball fields	Install a sidewalk to create accessible route	\$6,500	1
TOTAL WITHOUT PLAYGROUND SURFACE		\$26,200	
PLAYGROUND SURFACE COST		\$28,000	
TOTAL		\$54,200

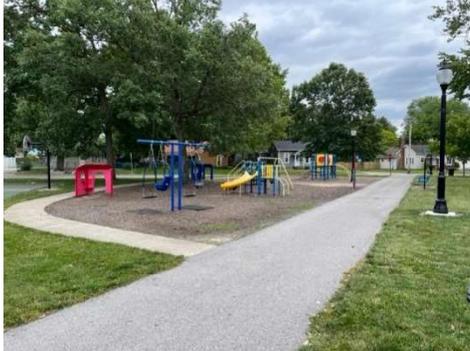
North Side of South Play Area

WASHINGTON PARK DEFICIENCIES	RECOMMENDATION	TOTAL COST	PRIORITY
1. The slope of the accessible parking spaces is steeper than the 1:48 maximum	Regrade parking spaces	\$3,000	1
2. There is no handicap sign to identify handicap parking space	Install handicap parking sign	\$200 each	1
3. There is not proper toe clearance under the sink in the Men's and Women's rooms	Rearrange sink piping to meet toe clearance requirements	\$300 each	3
4. The flush control is not located on the open side of the stall	Install toilet with flush control on the open side	\$500	3
5. There is not an accessible route within the play area to connect play components	Add accessible playgrounds surface within play area	\$28,000 each	1
